# ITSENSOR PIEZO

# Product Manual

Precision in speed control that  
**transforms enforcement**

**Pumatronix Equipamentos Eletrônicos Ltda.**

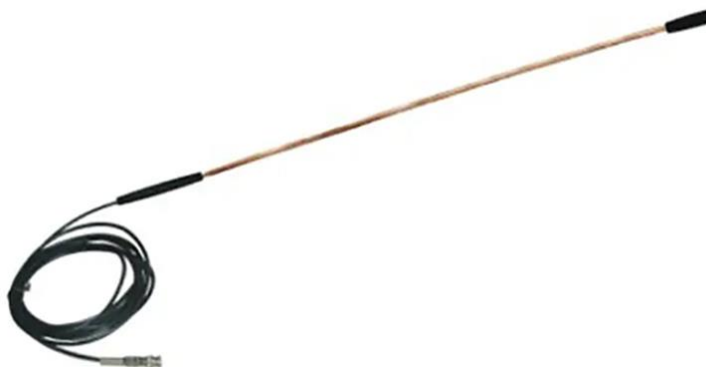
Figure 1 – ITSENSOR PIEZO

The weigh-in-motion ITSENSOR PIEZO is a state-of-the-art device that supports vehicle weighing and classification inspection operations.

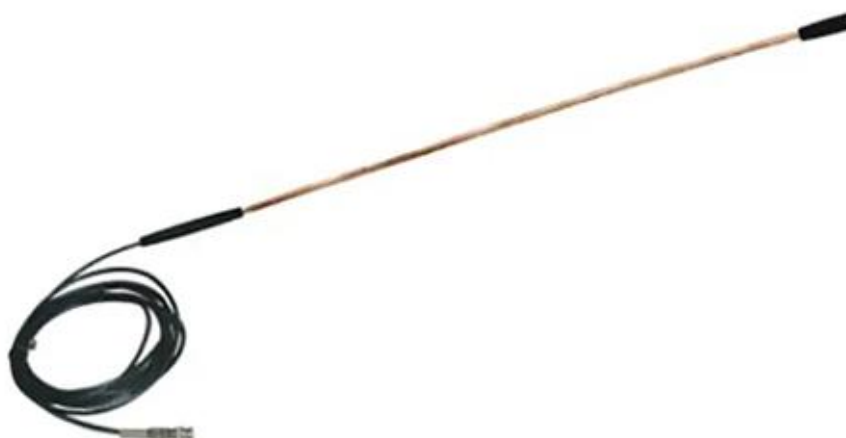
Figure 3

- 1) ITSENSOR PIEZO: Part containing the Sensor and connections to the Processing Cabinet. The Sensor measurement is variable and can be 1.5m, 2m, 2.5m, 3.0m, 3.3m, 3.5m and 5.5 meters. All sensor sizes come with a 40 meter cable.

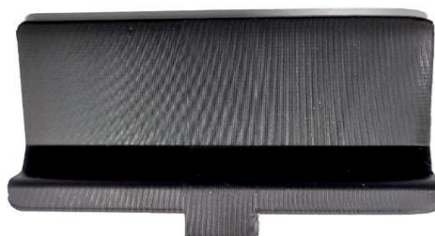
3) Application Tool: Aid tool for placing the ITSENSOR PIEZO in the floor slots.

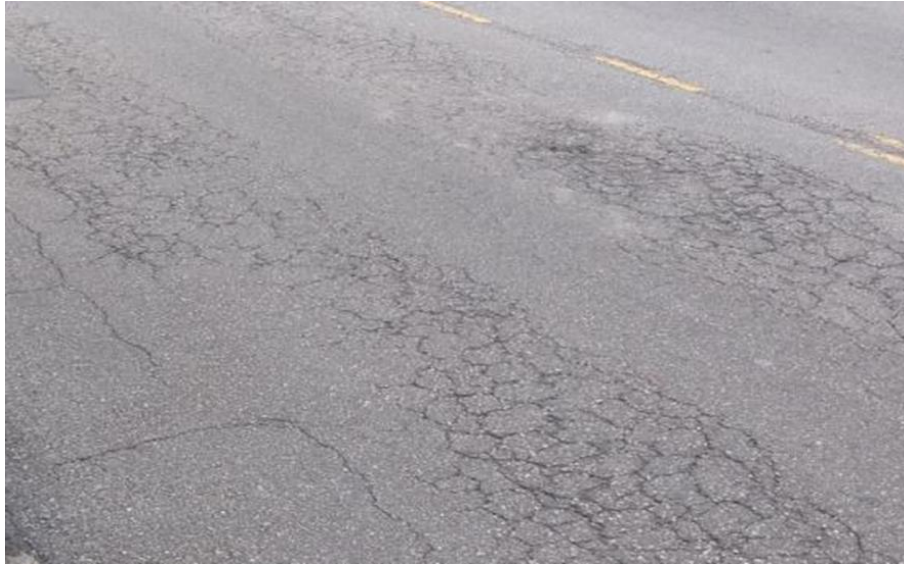
The area subjected to repeated traffic action forms, over time, two of the main defects in flexible pavements, which are Fatigue Cracking in the Pavement, also called alligator cracking, and Permanent Deformation in the Wheel Track (Rutting).

Fatigue cracks are interconnected cracks forming small blocks, often called "alligator cracking". These fatigue cracks, which should not be confused with Block Cracking, are caused by structural problems, such as undersizing of layers, structural weakening of the pavement during rainy periods, or even repeated traffic action during the design period.

Permanent deformations in the wheel track are deflections caused in the tire tread area. It can be caused by undersizing of the pavement layers, errors in the dosage of the asphalt mixture, lack of compaction with subsequent consolidation by traffic, or by shear caused by weakening. Figure 8 illustrates fatigue cracks and permanent deformation in the wheel track, clearly showing the area where the tires pass through.

*Figure 6 - Permanent Deformation (Rutting) and Fatigue Cracking in the wheel track.*

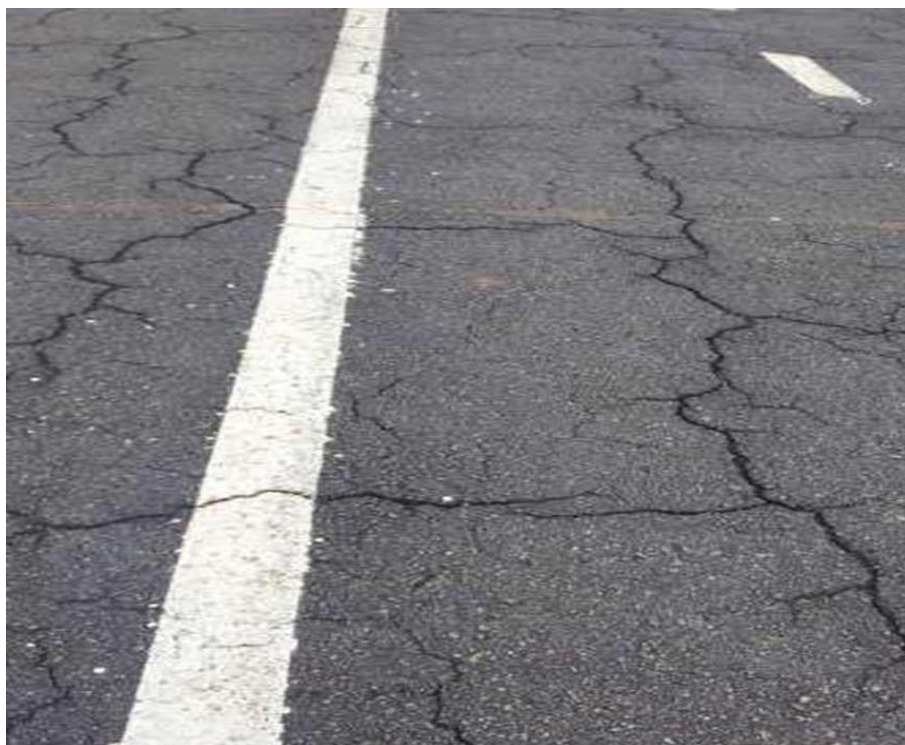
The big visual difference between block cracks and fatigue cracks is most often the block size and patterns. Block Cracks are generally larger and have a shape very close to a rectangle, unlike what occurs with fatigue cracks. Furthermore, these cracks are not related to fatigue and are often caused by changes in the viscosity of the coating layer or contraction and expansion of other pavement layers due to temperature variations throughout the day.

Cracks can also appear due to the use of a high percentage of fine aggregates and a Petroleum Asphalt Cement (PAC) with a lower penetration value, i.e., higher viscosity. Furthermore, the low volume of traffic in the first years of the pavement, during the consolidation phase, can accelerate the pavement aging process. The severity of these cracks is related to the size of the opening, and the presence of erosion in the corners. Cracks must be sealed or treated to prevent water from entering and subsequently causing other defects to appear. Figure 9 illustrates the defect.

*Figure 7 - Block cracking. Source: Author (2018)*

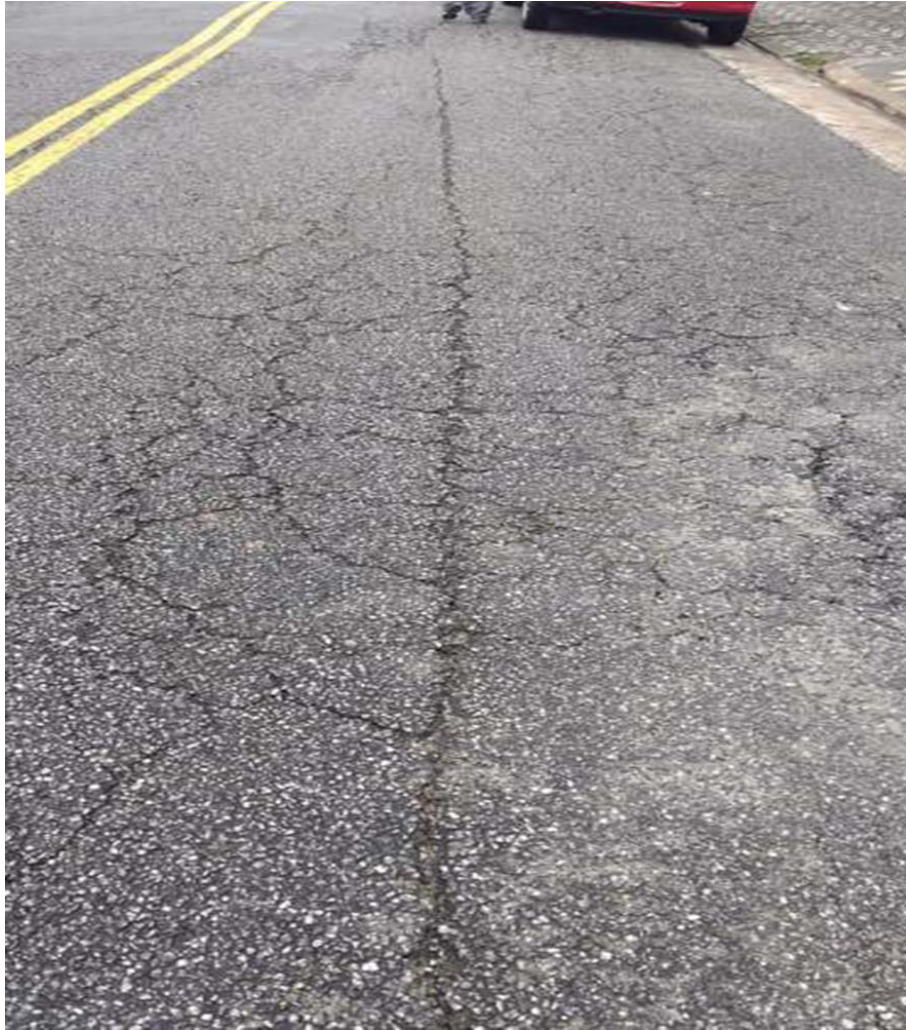
In addition to problems caused by traffic, pavements may present defects related to changes in temperature or poor execution. Longitudinal Cracks are cracks parallel to the axis of the road and can appear both in the wheel tracks and in other areas of the road. This defect is generally caused by poor execution of lane division joints.

Figure 10 illustrates Longitudinal Cracks. These defects are often confused with the beginning of a Fatigue Cracking, which presents the same pattern.

*Figure 8 - Longitudinal Cracking. Source: Author (2017)*

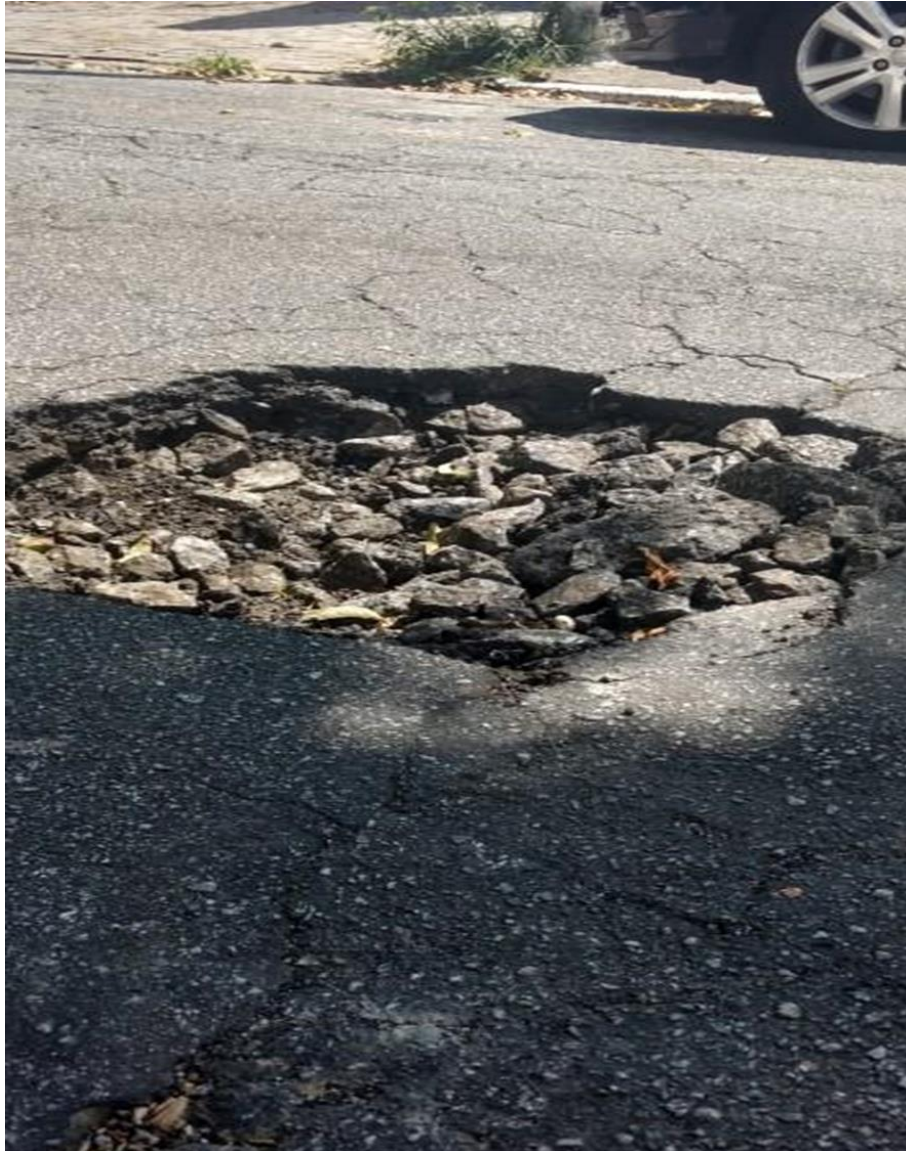
Another very common defect is Potholes. Potholes are holes due to the disintegration of parts of the coating and are caused by traffic or the presence of water. This type of defect begins with fatigue cracks and, over time, parts become detached from the pavement structure.

In addition to structural causes, potholes can have their origin in construction problems. Often in a rush for "results", not to mention a lack of ethics and supervision, some people carry out the coating without correctly applying the primer layer, or without waiting for it to cure. The absence of this procedure prevents adhesion between the layers, which in turn results in localized removal of the coating. The severity of the pots is measured based on the depth, which is greater than 5 centimeters and is considered high. Figure 11 illustrates a high severity pothole.

Figure 9 - Potholes. Source: Author (2018)

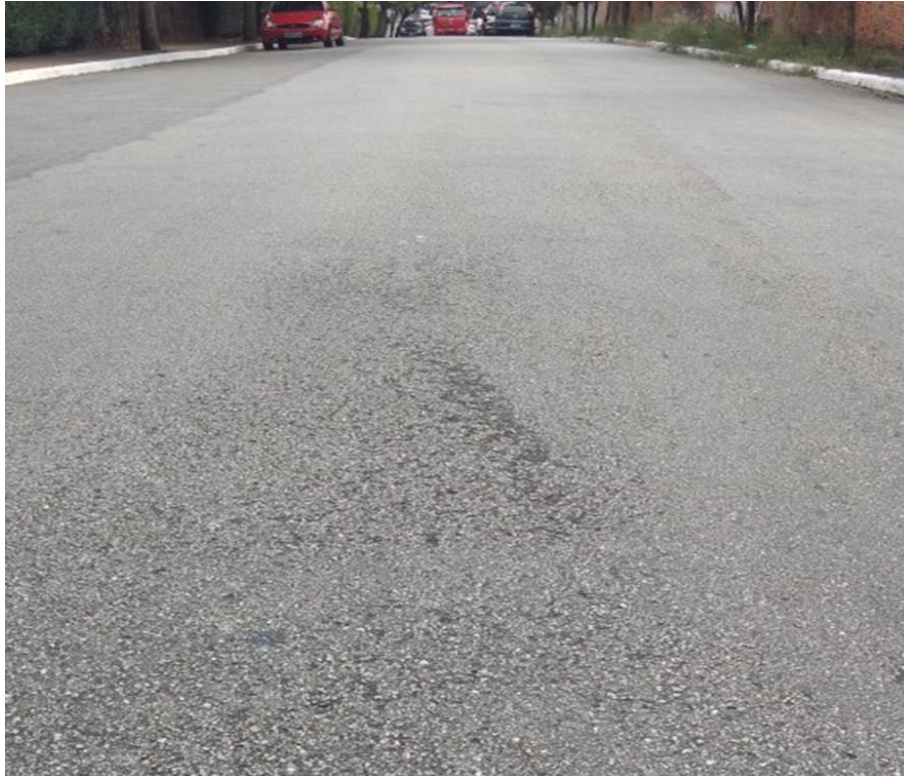
Bituminous materials contain organic compounds maltenes and asphaltenes. Maltenes constitute the oily part of the material, with plastic and viscosity properties. Asphaltene is the solid portion of the material and provides rigidity properties. As the material ages and climate changes, maltenes transform into asphaltenes. This change in bituminous materials also generates defects called Raveling.

Raveling is related to the loss of adhesiveness of the bituminous material, caused by aging, hardening, oxidation or due to weathering. In addition to problems associated with the aging of the material, wear may be related to the lack of asphalt binder in the mixture, loss of adhesiveness due to the action of external chemical products or even opening to traffic before the binder adheres to the aggregate. Although raveling is often associated with overuse, it can be the result of other actions, including applying coatings in unfavorable conditions. Figure 12 illustrates raveling in the pavement.

*Figure 10 - Raveling. Source: Author (2018)*

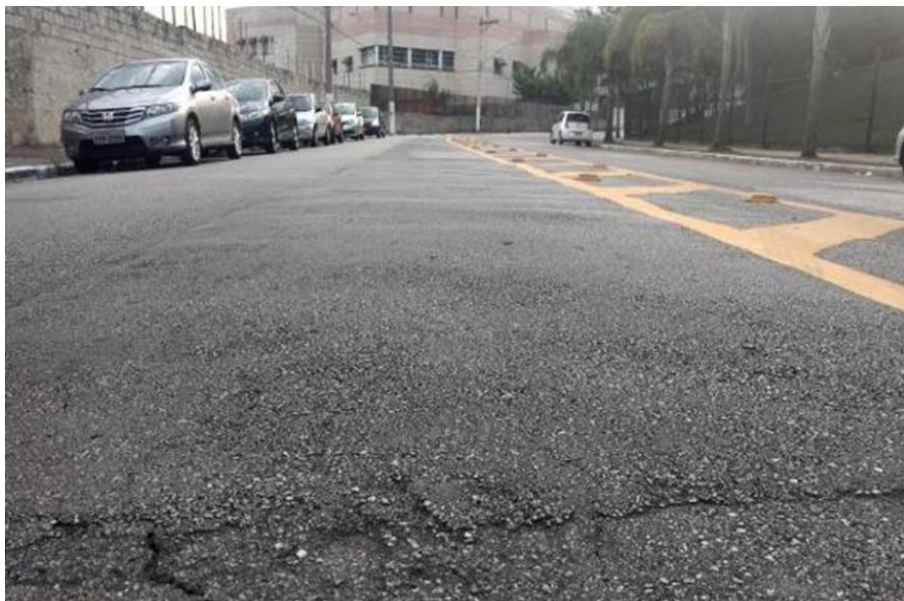
One of the characteristics of a pavement is to resist the horizontal forces imposed by traffic. Corrugations in pavements are plastic deformations that form certain undulations on the surface. This defect is generally the result of tangential forces, that is, acceleration and braking forces that the tires exert on the asphalt pavement.

The reason for its appearance is linked to structural failures (very thin coating thicknesses), failures in the asphalt mixture dosage or even construction problems. In the case of thin layers, braking and acceleration movements can cause the layer to "slip" due to the low stability of the mixture, generating corrugations. Figure 13 exemplifies the defect in front of the CERET Park in Anália Franco in São Paulo, close to a traffic light.

*Figure 11 - Shoving and Corrugation. Source: Author (2018)*

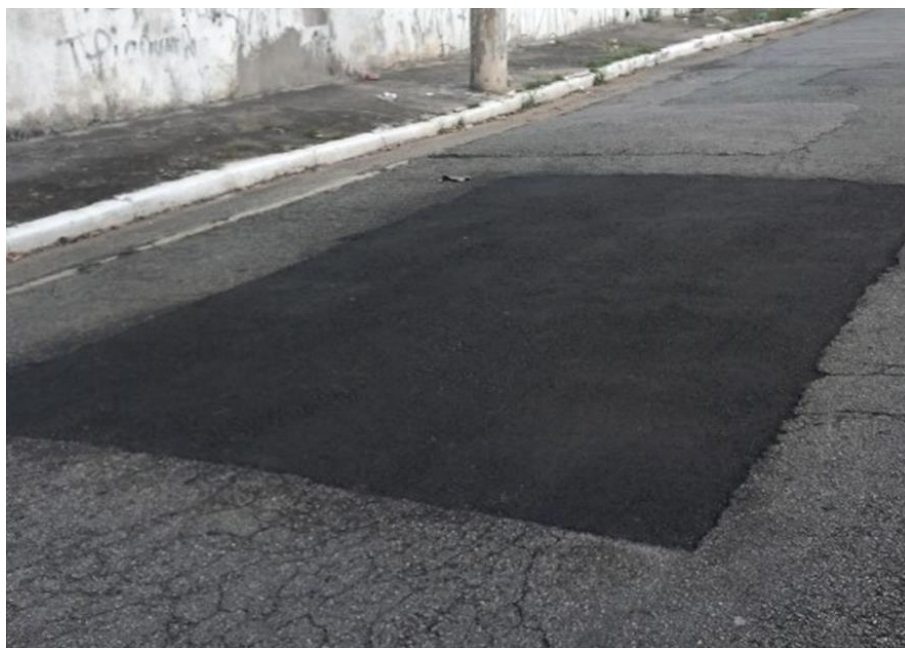
A patch is an area of pavement where the original material has been removed and replaced with new material. They are mainly used to correct potholes, which if not corrected can further compromise the structure. Although they are used for correction, patches are also considered defects in the pavement.

This occurs because the presence of a patched area indicates that some other defect has already occurred there. Therefore, they are considered as defects so that the area is not ignored and is always monitored to prevent the appearance of other defects. However, patches do not apply to all cases of pavement deterioration and must be analyzed on a case-by-case basis.

Figure 14, for example, indicates a patched area but with several cracks around it. In other words, as soon as the cracks propagate, it will deteriorate again.

*Figure 12 - Patch. Source: Author (2018)*

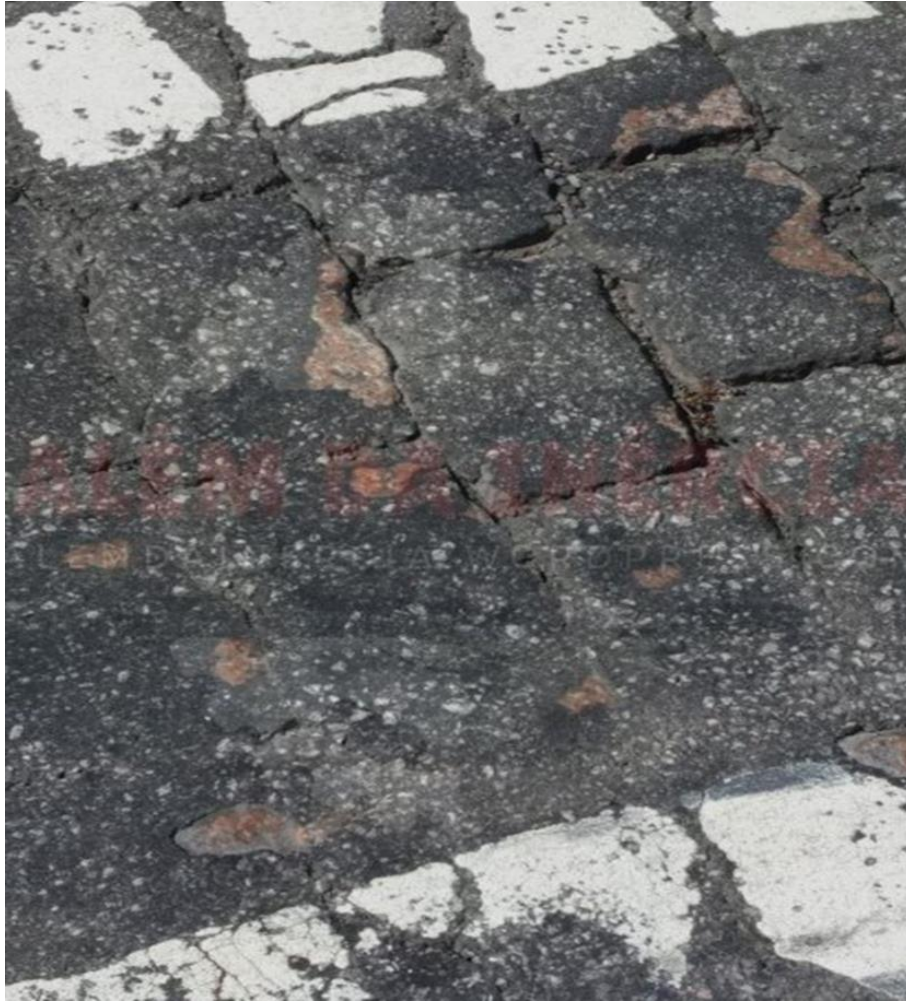
Reflection Cracking is a crack that appears due to problems with the lower layer, such as base cracks that appear in the coating. These cracks are also linked to the rigidity of the layer where the asphalt coating is laid. In the case of parallelepipeds, which are highly rigid materials, their shape is reflected in the coating layer as cracks, as shown in Figure 15. These materials, because they have a smooth surface, do not adhere to the asphalt layer, and over time this ends up coming loose from the structure, Figure 16.

*Figure 13 - Reflection Cracking. Source: Author (2018)*

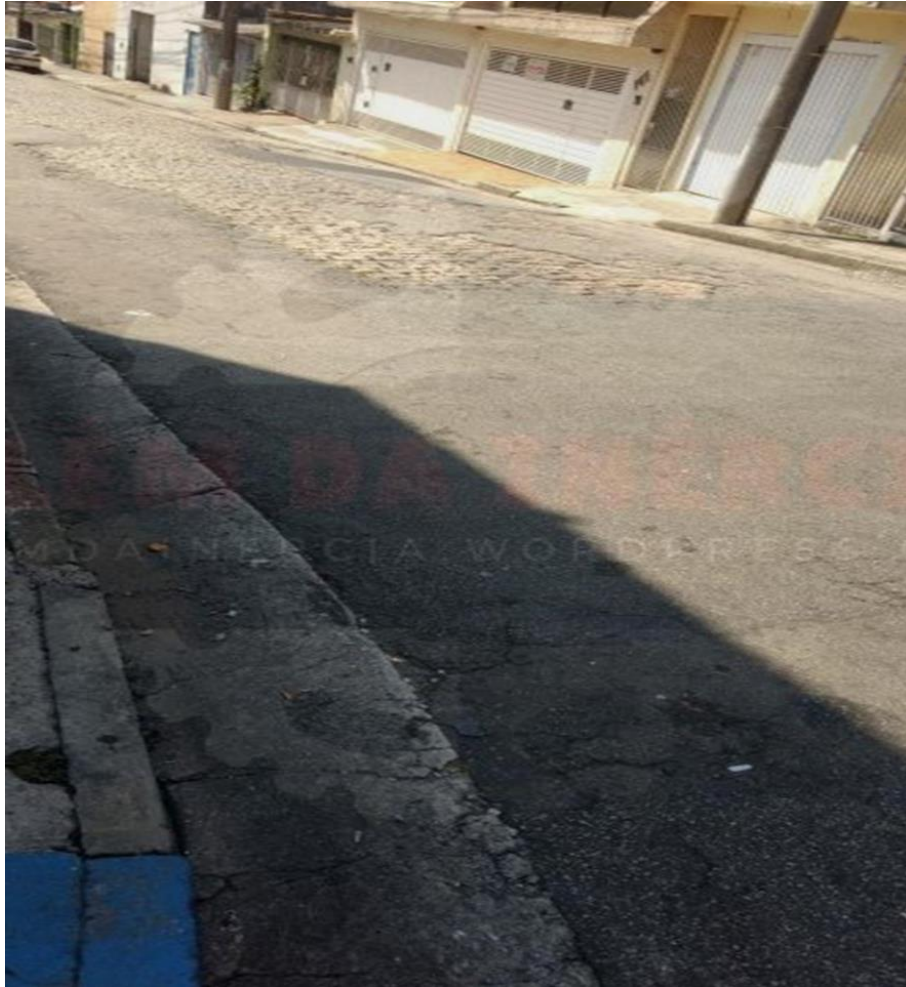
In the past, it was common to use cobblestones as the last layer of paving, and there are several parts of cities where these materials can still be found. However, overlapping these materials with an asphalt layer can cause defects.

Figure 14 - Lack of adhesion on cobblestones. Source: Author (2018)

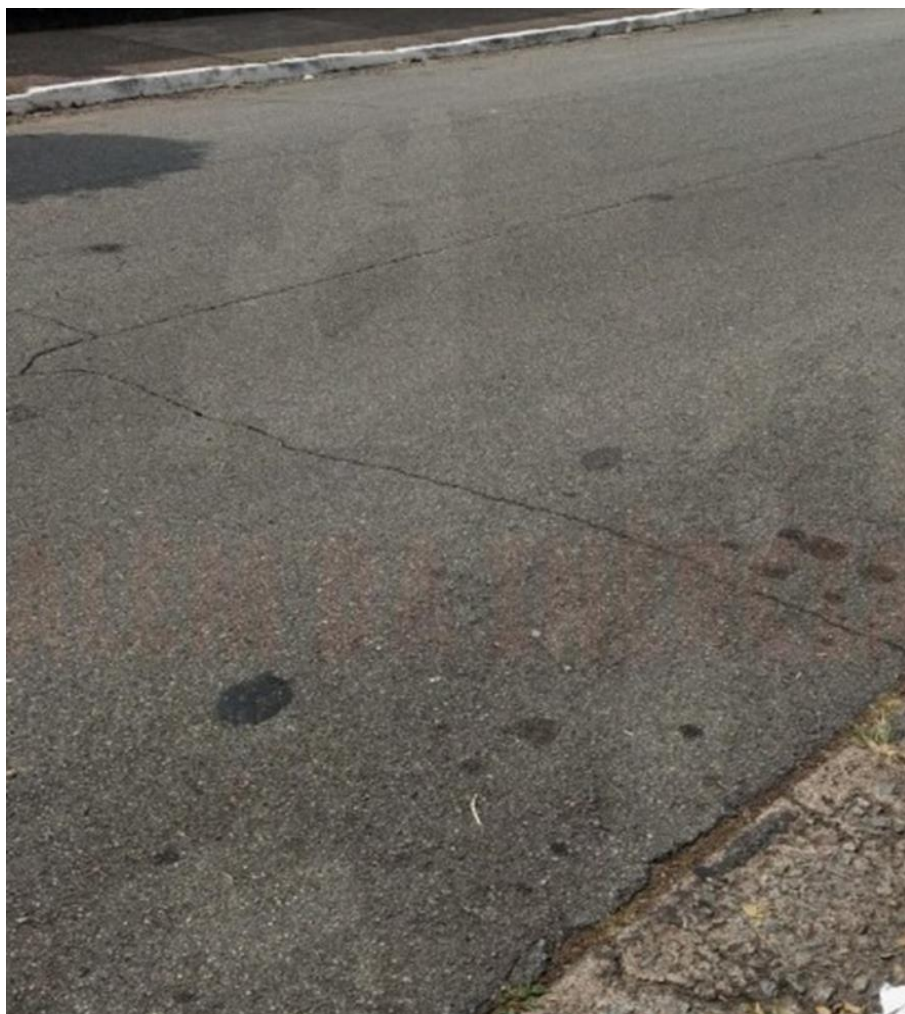
Transverse Cracking occurs perpendicular to the axis of the track and is generally related to thermal contraction of the coating or the lower layer, and can also be caused by reflection. Figure 17 illustrates a transverse crack connecting to a longitudinal crack.

*Figure 15 - Transverse Cracking. Source: Author (2018)*

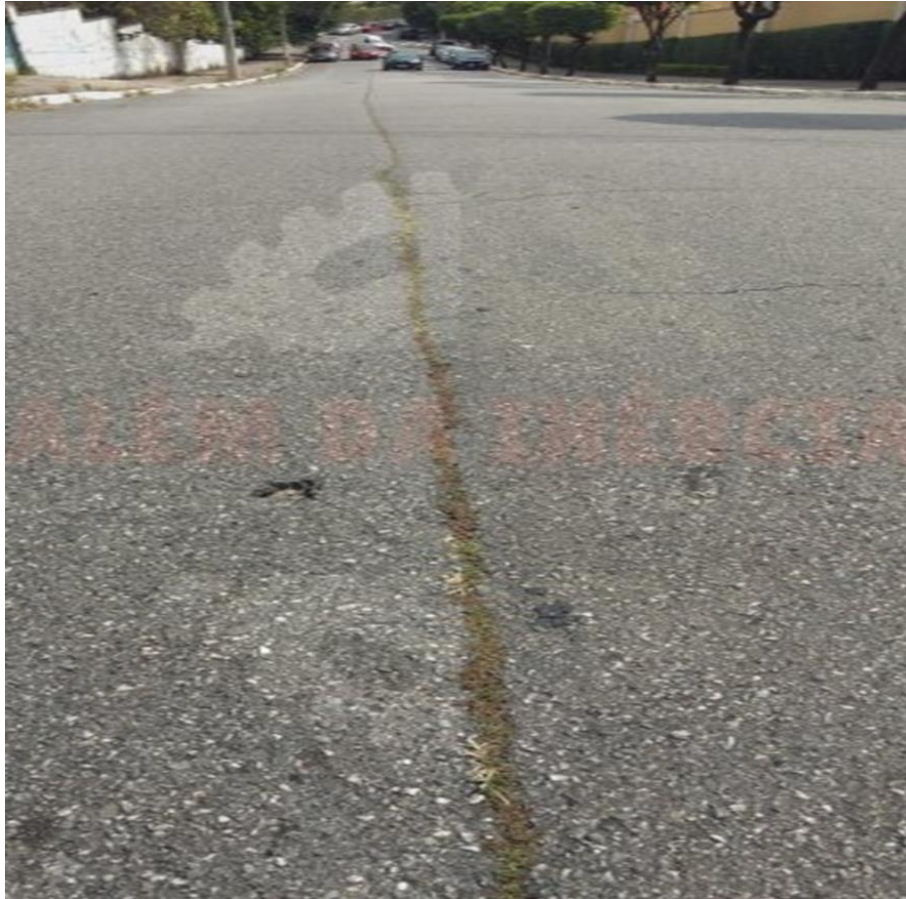
Pumping consists of the exit of materials through cracks or joints and can be divided into two categories. When water leaks out, international literature classifies this type of pumping as "Water Bleeding". When the material expelled from the structure is water and fines from the lower layer, it is called Pumping.

Pumping occurs by applying mobile loads to the pavement, increasing pressure and causing material to escape through cracks. The presence of water stored in the lower layers is one of the reasons why these defects occur, also leading to a decrease in support capacity. Furthermore, the presence of fines or vegetation in cracked regions indicates the presence of water accumulation and pumping in the pavement. This defect may also be related to the lack of adequate drainage, Figure 16 indicates the occurrence, very common in urban areas.

*Figure 16 - Pumping and Water Bleeding. Source: Author (2018)*

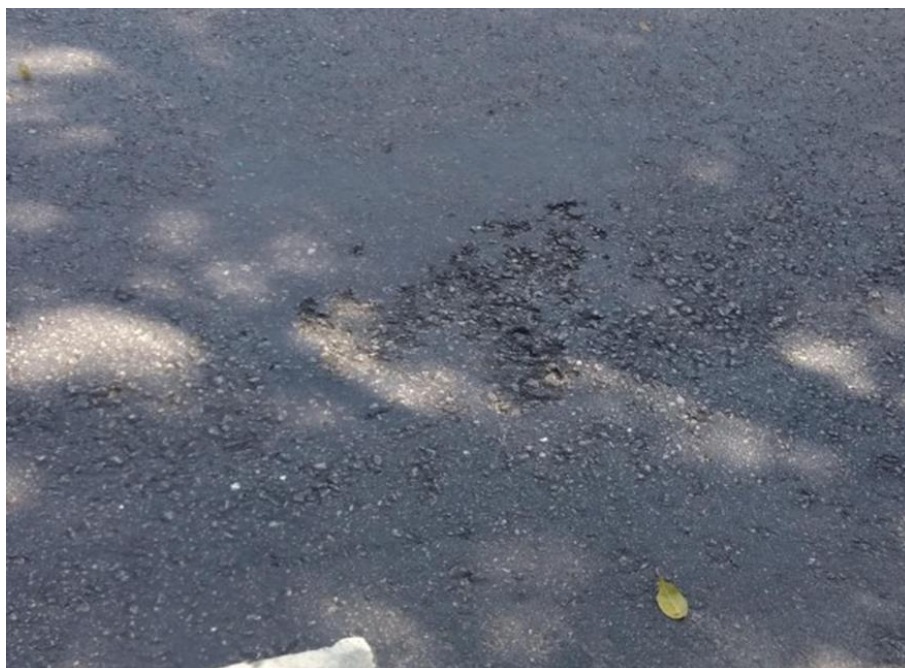
Defects often occur due to non-compliance in execution or errors in projects, dosages, etc. Bleeding is the excess of asphalt binder on the surface of a flexible pavement, which becomes easily identifiable by the reflection it causes when exposed to light.

This defect is caused by a set of errors. They often occur due to errors in the dosage of the asphalt mixture, such as using a high level of binder. It can also be caused by excessive priming at the time of execution, or by a lack of voids in the asphalt mixture dosage.

*Figure 17 - Bleeding. Source: Author (2018)*

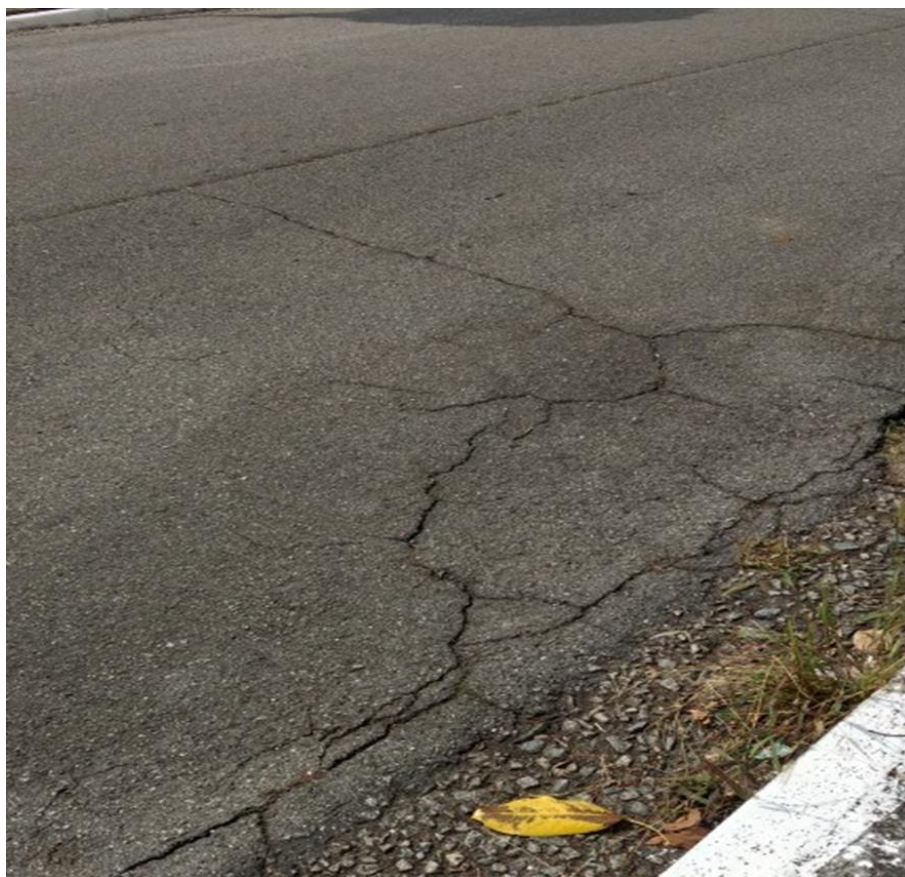
In Pavements that do not have roadsides or lack lateral confinement, crack defects occur at the edges. Edge Cracking occurs due to insufficient compaction of the mix, poor drainage in the pavement or, as mentioned, lack of lateral confinement and these cracks generally have a parabolic appearance.

Figure 20 illustrates an edge cracking connecting to other cracks (transverse and longitudinal), and with the presence of vegetation, most likely due to poor drainage.

*Figure 18 - Edge Cracking. Source: Author (2018)*

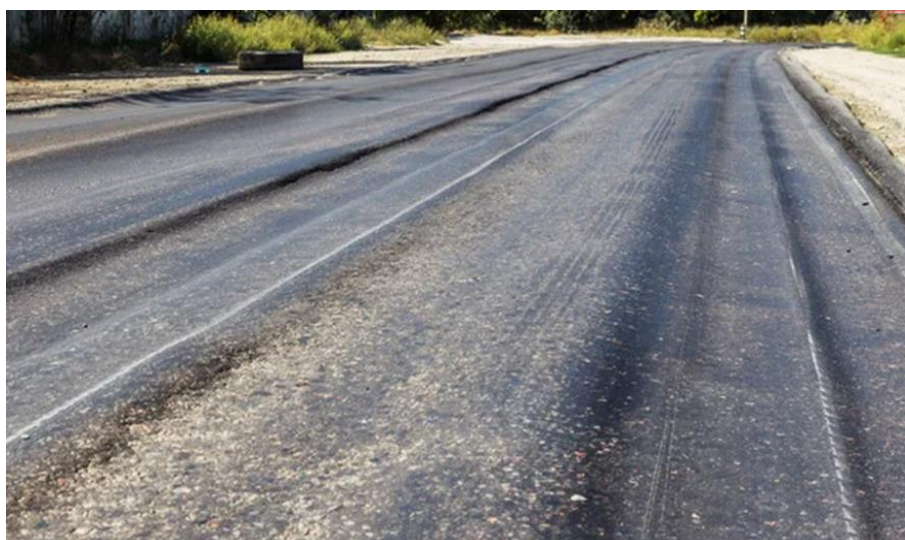
*Figure 19*

On pavements that do not have a good base or where vehicles with excess weight circulate, ripples appear, displacing the CBU asphalt to the intermediate regions where the wheels of trucks and vehicles pass.

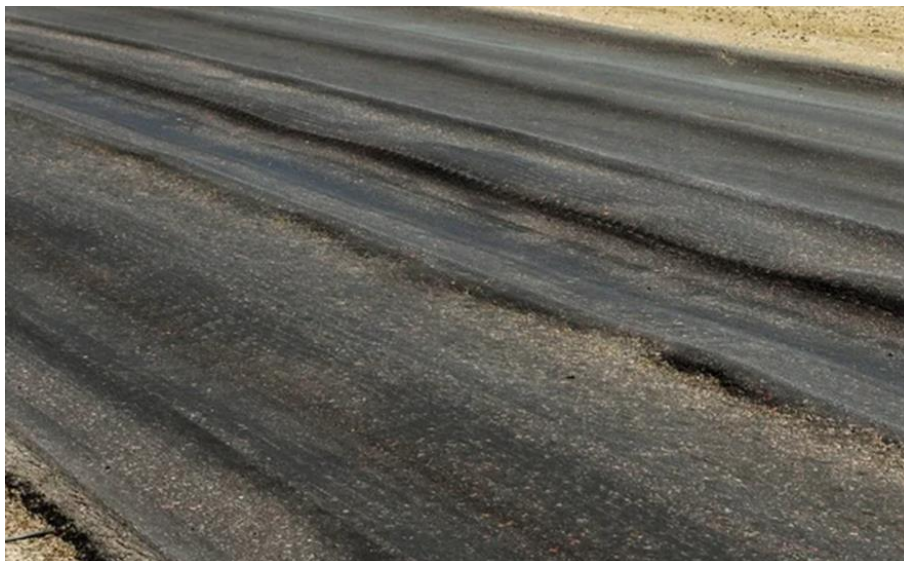
*Figure 20 - Deformations or ripples caused by the passage of very heavy vehicles and/or poor quality of the applied base*
