ITSENSOR  
PIEZO

# Product Manual

REVISION 1.2.0 - 2025

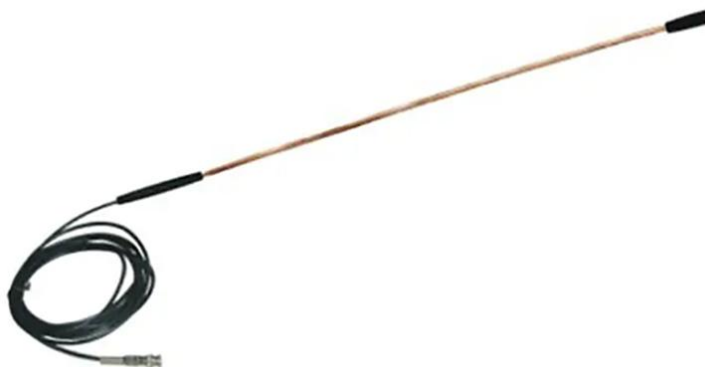
The weigh-in-motion ITSENSOR PIEZO is a state-of-the-art device that supports vehicle weighing and classification inspection operations.

*Figure 1 – ITSENSOR PIEZO*

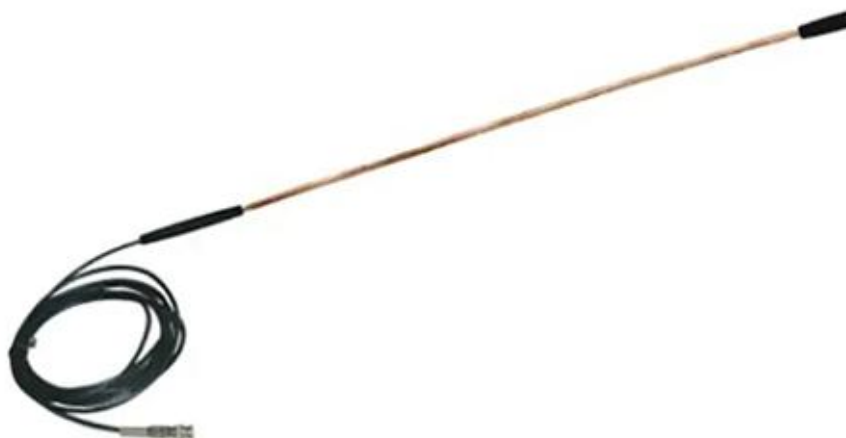
Figure 3

- 1) ITSENSOR PIEZO: Part containing the Sensor and connections to the Processing Cabinet. The Sensor measurement is variable and can be 1.5m, 2m, 2.5m, 3.0m, 3.3m, 3.5m and 5.5 meters. All sensor sizes come with a 40 meter cable.

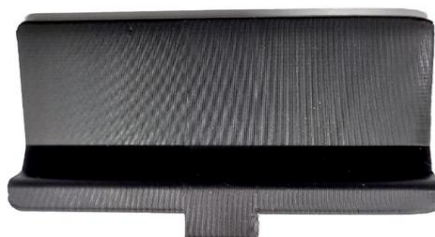
3) Application Tool: Aid tool for placing the ITSENSOR PIEZO in the floor slots.

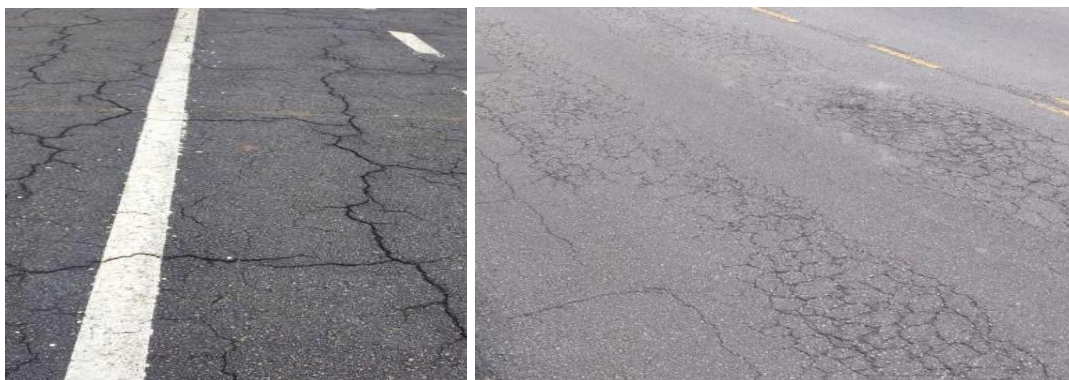
*Figure 6*

- Check whether there are cracks in the pavement.

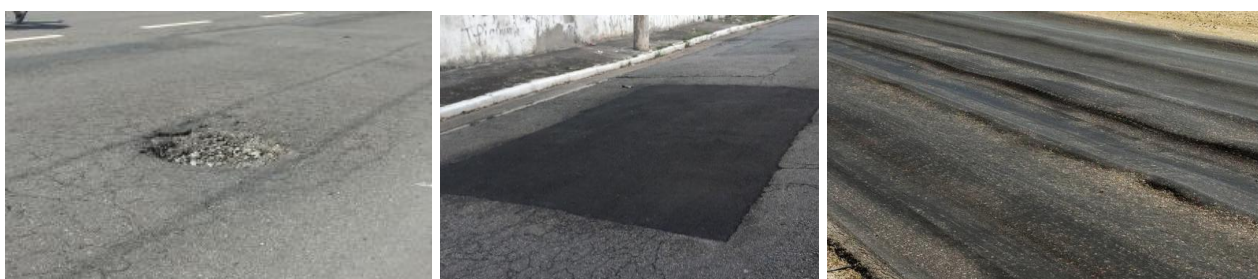
*Figure 7*

- Observe the presence of undulations, potholes, or recent patches.

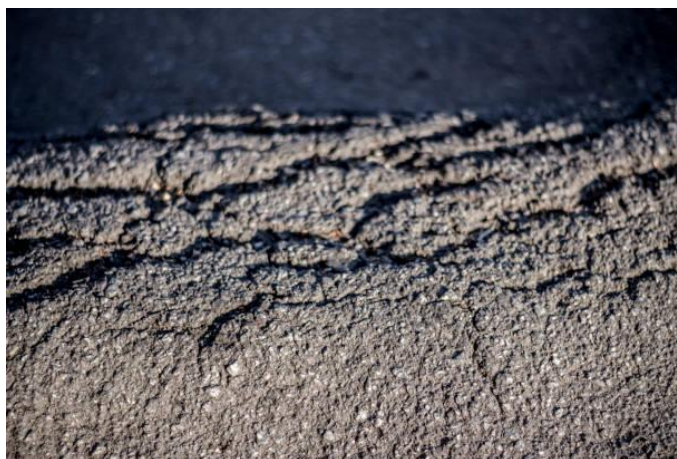
*Figure 8*

- Identify whether the stretch has been resurfaced or still has the original pavement.
- Evaluate whether the asphalt is smooth or rough.

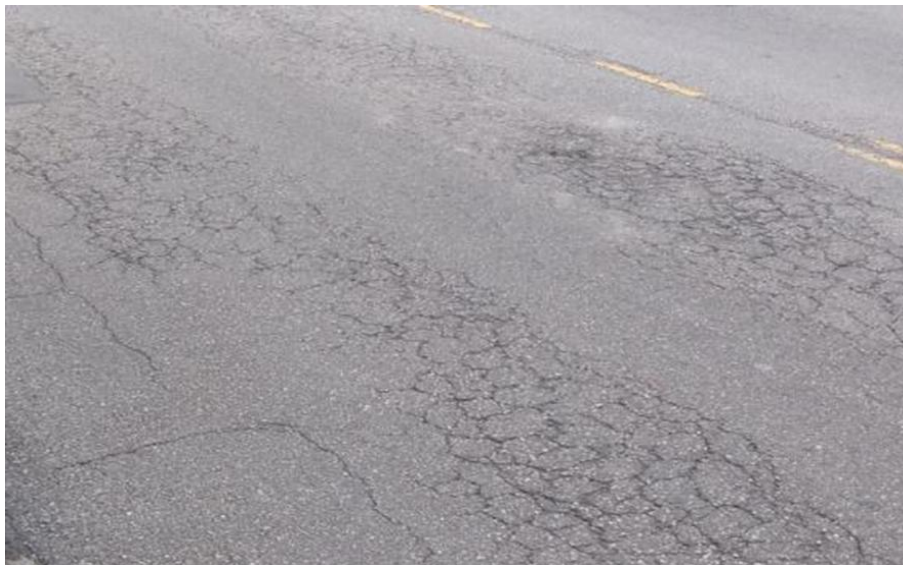
The area subjected to repeated traffic action forms, over time, two of the main defects in flexible pavements, which are Fatigue Cracking in the Pavement, also called alligator cracking, and Permanent Deformation in the Wheel Track (Rutting).

Fatigue cracks are interconnected cracks forming small blocks, often called "alligator cracking". These fatigue cracks, which should not be confused with Block Cracking, are caused by structural problems, such as undersizing of layers, structural weakening of the pavement during rainy periods, or even repeated traffic action during the design period.

Permanent deformations in the wheel track are deflections caused in the tire tread area. It can be caused by undersizing of the pavement layers, errors in the dosage of the asphalt mixture, lack of compaction with subsequent consolidation by traffic, or by shear caused by weakening. Figure 8 illustrates fatigue cracks and permanent deformation in the wheel track, clearly showing the area where the tires pass through.

*Figure 9 - Permanent Deformation (Rutting) and Fatigue Cracking in the wheel track.*

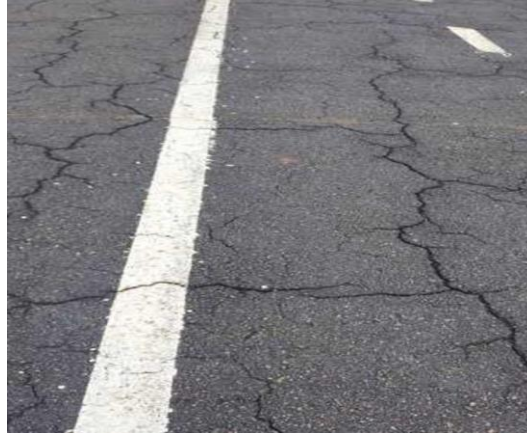
The big visual difference between block cracks and fatigue cracks is most often the block size and patterns. Block Cracks are generally larger and have a shape very close to a rectangle, unlike what occurs with fatigue cracks. Furthermore, these cracks are not related to fatigue and are often caused by changes in the viscosity of the coating layer or contraction and expansion of other pavement layers due to temperature variations throughout the day.

Cracks can also appear due to the use of a high percentage of fine aggregates and a Petroleum Asphalt Cement (PAC) with a lower penetration value, i.e., higher viscosity. Furthermore, the low volume of traffic in the first years of the pavement, during the consolidation phase, can accelerate the pavement aging process. The severity of these cracks is related to the size of the opening, and the presence of erosion in the corners. Cracks must be sealed or treated to prevent water from entering and subsequently causing other defects to appear. Figure 9 illustrates the defect.

*Figure 10 - Block cracking. Source: Author (2018)*

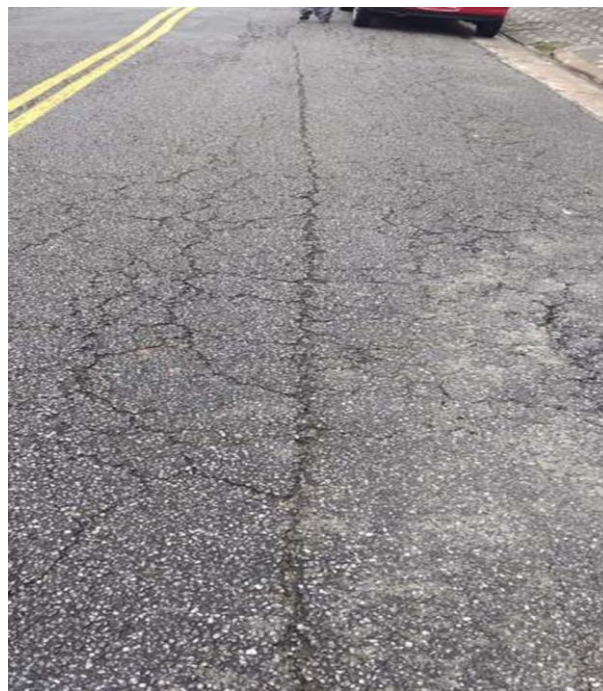
In addition to problems caused by traffic, pavements may present defects related to changes in temperature or poor execution. Longitudinal Cracks are cracks parallel to the axis of the road and can appear both in the wheel tracks and in other areas of the road. This defect is generally caused by poor execution of lane division joints.

Figure 10 illustrates Longitudinal Cracks. These defects are often confused with the beginning of a Fatigue Cracking, which presents the same pattern.

*Figure 11 - Longitudinal Cracking. Source: Author (2017)*

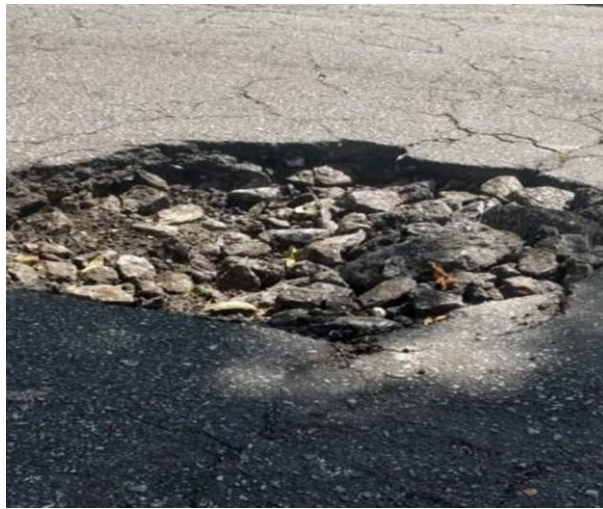
Another very common defect is Potholes. Potholes are holes due to the disintegration of parts of the coating and are caused by traffic or the presence of water. This type of defect begins with fatigue cracks and, over time, parts become detached from the pavement structure.

In addition to structural causes, potholes can have their origin in construction problems. Often in a rush for “results”, not to mention a lack of ethics and supervision, some people carry out the coating without correctly applying the primer layer, or without waiting for it to cure. The absence of this procedure prevents adhesion between the layers, which in turn results in localized removal of the coating. The severity of the pots is measured based on the depth, which is greater than 5 centimeters and is considered high. Figure 11 illustrates a high severity pothole.

*Figure 12 - Potholes. Source: Author (2018)*

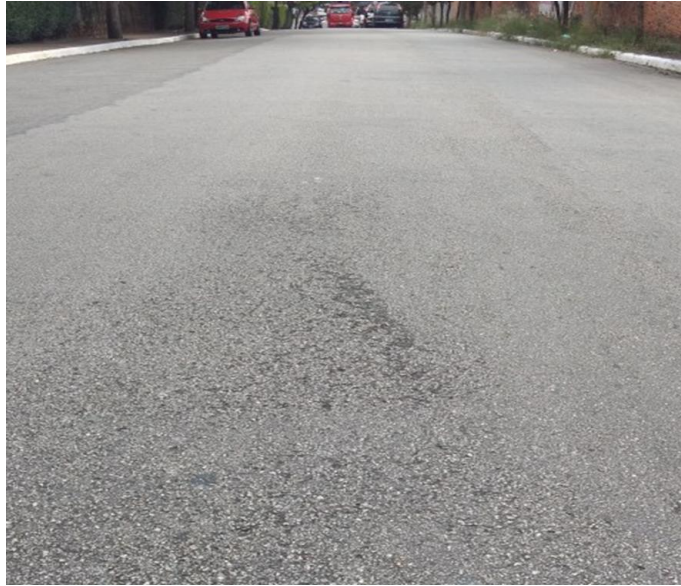
Raveling is related to the loss of adhesiveness of the bituminous material, caused by aging, hardening, oxidation or due to weathering. In addition to problems associated with the aging of the material, wear may be related to the lack of asphalt binder in the mixture, loss of adhesiveness due to the action of external chemical products or even opening to traffic before the binder adheres to the aggregate. Although raveling is often associated with overuse, it can be the result of other actions, including applying coatings in unfavorable conditions. Figure 12 illustrates raveling in the pavement.

*Figure 13 - Raveling. Source: Author (2018)*

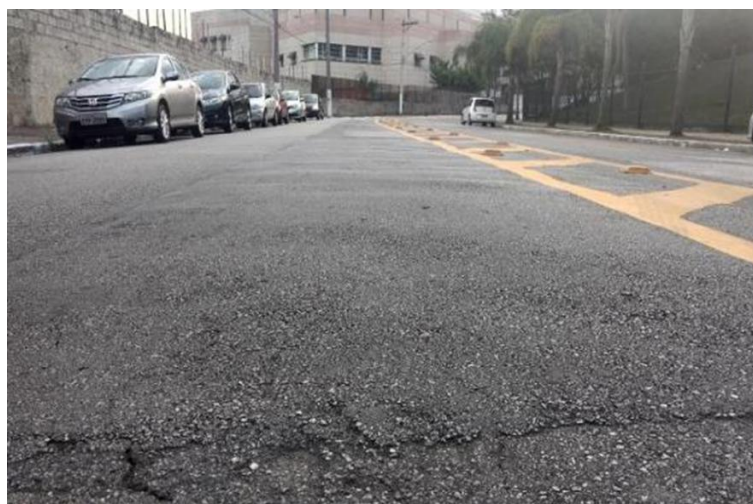
One of the characteristics of a pavement is to resist the horizontal forces imposed by traffic. Corrugations in pavements are plastic deformations that form certain undulations on the surface. This defect is generally the result of tangential forces, that is, acceleration and braking forces that the tires exert on the asphalt pavement.

The reason for its appearance is linked to structural failures (very thin coating thicknesses), failures in the asphalt mixture dosage or even construction problems. In the case of thin layers, braking and acceleration movements can cause the layer to "slip" due to the low stability of the mixture, generating corrugations. Figure 13 exemplifies the defect in front of the CERET Park in Anália Franco in São Paulo, close to a traffic light.

*Figure 14 - Shoving and Corrugation. Source: Author (2018)*

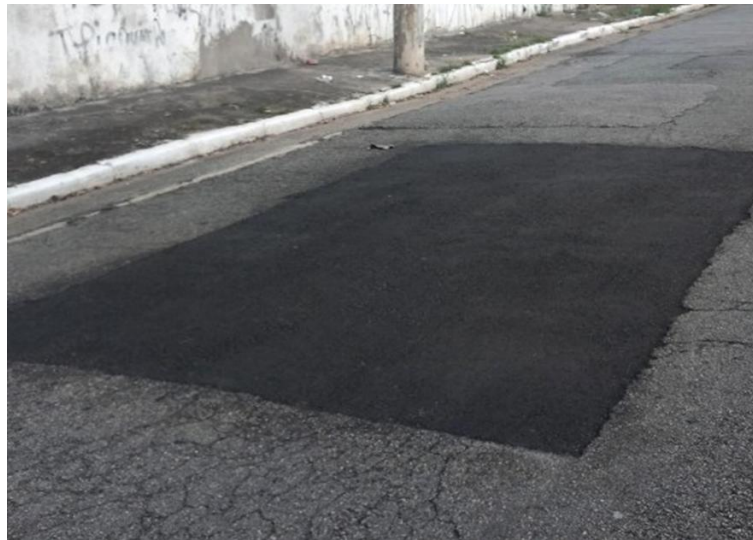
A patch is an area of pavement where the original material has been removed and replaced with new material. They are mainly used to correct potholes, which if not corrected can further compromise the structure. Although they are used for correction, patches are also considered defects in the pavement.

Figure 14, for example, indicates a patched area but with several cracks around it. In other words, as soon as the cracks propagate, it will deteriorate again.

*Figure 15 - Patch. Source: Author (2018)*

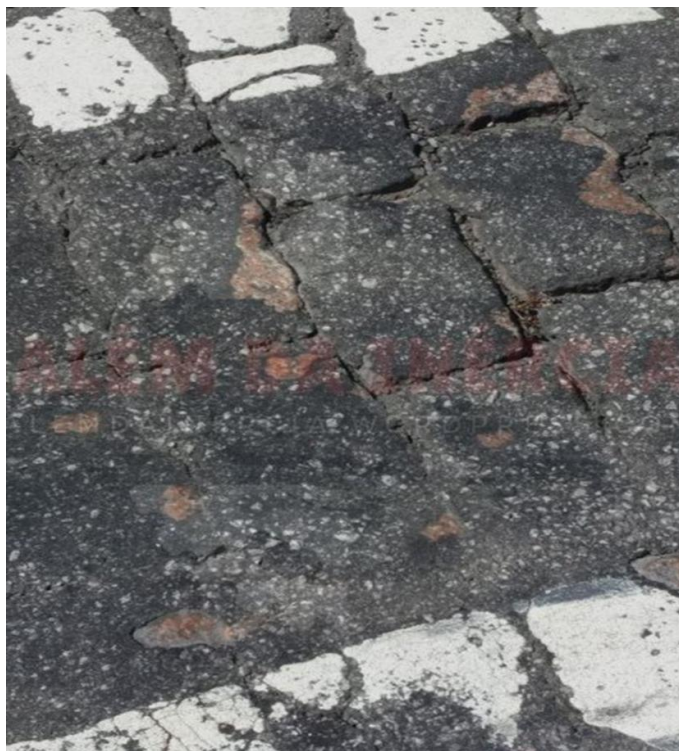
Reflection Cracking is a crack that appears due to problems with the lower layer, such as base cracks that appear in the coating. These cracks are also linked to the rigidity of the layer where the asphalt coating is laid. In the case of parallelepipeds, which are highly rigid materials, their shape is reflected in the coating layer as cracks, as shown in Figure 15. These materials, because they have a smooth surface, do not adhere to the asphalt layer, and over time this ends up coming loose from the structure, Figure 16.

*Figure 16 - Reflection Cracking. Source: Author (2018)*

Crack Reflection, or simply crack propagation, is a phenomenon that occurs due to the full contact of an upper layer of asphalt mixture with a lower layer that has fissures on its surface.

When a cracked pavement in the lower layer is subjected to a load, a different state of stress occurs in the contact region. This means that the distribution of stresses does not occur uniformly across the pavement,

generating a concentration at some points. Therefore, cracks tend to reflect at these points where the discontinuity in the distribution of forces occurs.

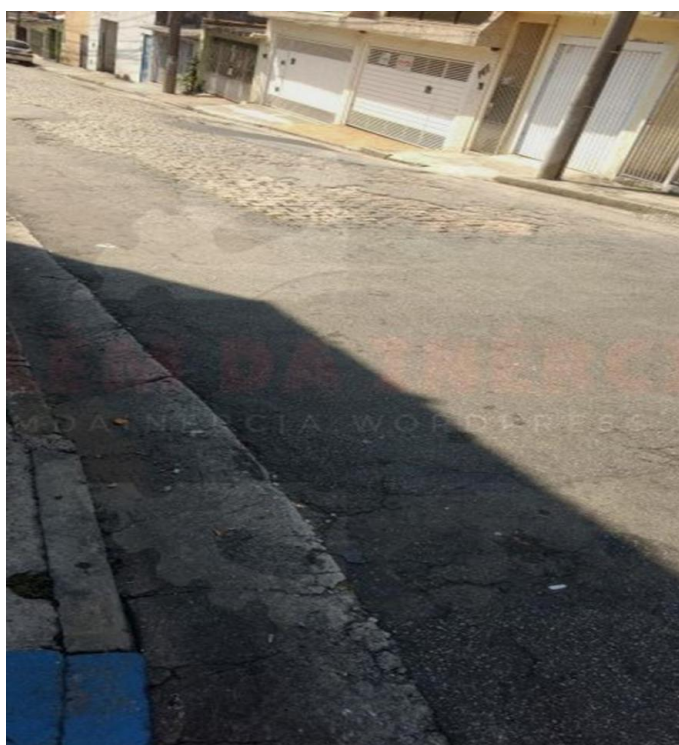
*Figure 17 - Lack of adhesion on cobblestones. Source: Author (2018)*

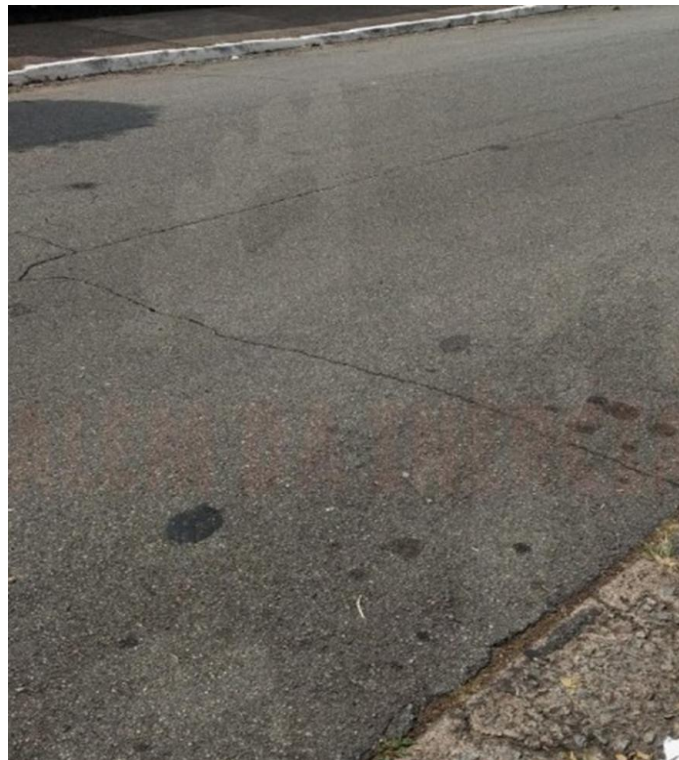
Transverse Cracking occurs perpendicular to the axis of the track and is generally related to thermal contraction of the coating or the lower layer, and can also be caused by reflection. Figure 17 illustrates a transverse crack connecting to a longitudinal crack.

*Figure 18 - Transverse Cracking. Source: Author (2018)*

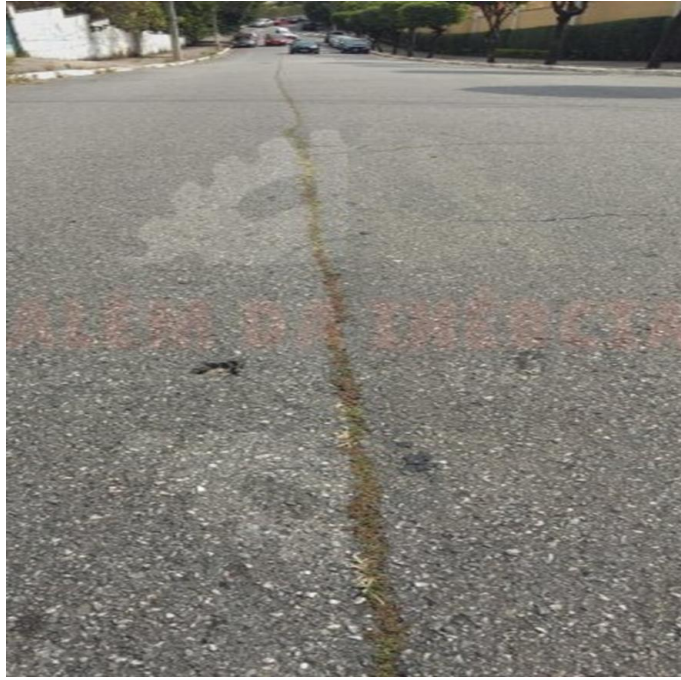
Pumping consists of the exit of materials through cracks or joints and can be divided into two categories. When water leaks out, international literature classifies this type of pumping as "Water Bleeding". When the material expelled from the structure is water and fines from the lower layer, it is called Pumping.

Pumping occurs by applying mobile loads to the pavement, increasing pressure and causing material to escape through cracks. The presence of water stored in the lower layers is one of the reasons why these defects occur, also leading to a decrease in support capacity. Furthermore, the presence of fines or vegetation in cracked regions indicates the presence of water accumulation and pumping in the pavement. This defect may also be related to the lack of adequate drainage, Figure 16 indicates the occurrence, very common in urban areas.

*Figure 19 - Pumping and Water Bleeding. Source: Author (2018)*

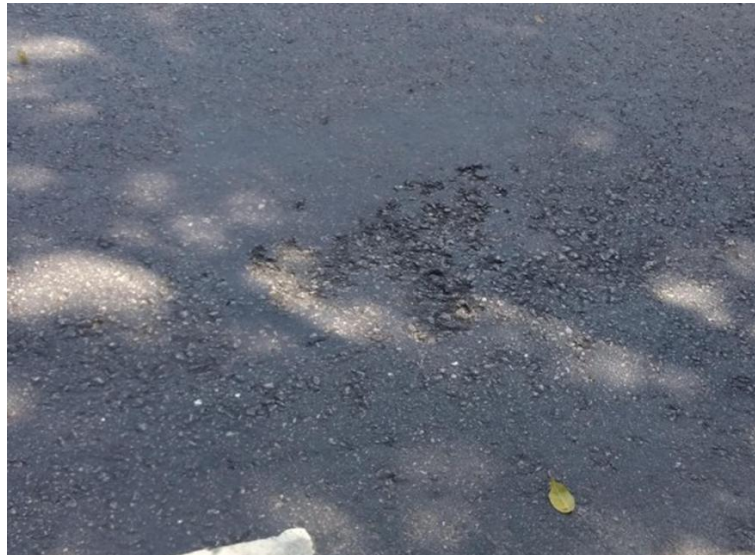
Defects often occur due to non-compliance in execution or errors in projects, dosages, etc. Bleeding is the excess of asphalt binder on the surface of a flexible pavement, which becomes easily identifiable by the reflection it causes when exposed to light.

This defect is caused by a set of errors. They often occur due to errors in the dosage of the asphalt mixture, such as using a high level of binder. It can also be caused by excessive priming at the time of execution, or by a lack of voids in the asphalt mixture dosage.

Both defects not only cause problems with the “appearance” of the pavement, but the excess/lack of binder and the polishing of the aggregates also influence the macrotexture of the pavements. With the macrotexture affected, the coefficient of friction decreases and can lead to accidents due to aquaplaning, mainly. Figure 19 illustrates bleeding.

*Figure 20 - Bleeding. Source: Author (2018)*

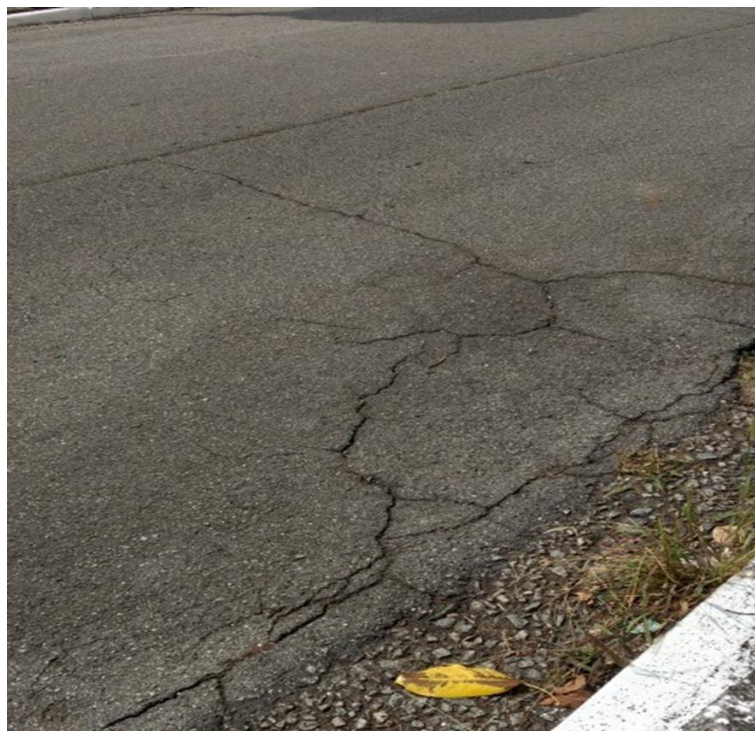
In Pavements that do not have roadsides or lack lateral confinement, crack defects occur at the edges. Edge Cracking occurs due to insufficient compaction of the mix, poor drainage in the pavement or, as mentioned, lack of lateral confinement and these cracks generally have a parabolic appearance.

Figure 20 illustrates an edge cracking connecting to other cracks (transverse and longitudinal), and with the presence of vegetation, most likely due to poor drainage.

*Figure 21 - Edge Cracking. Source: Author (2018)*

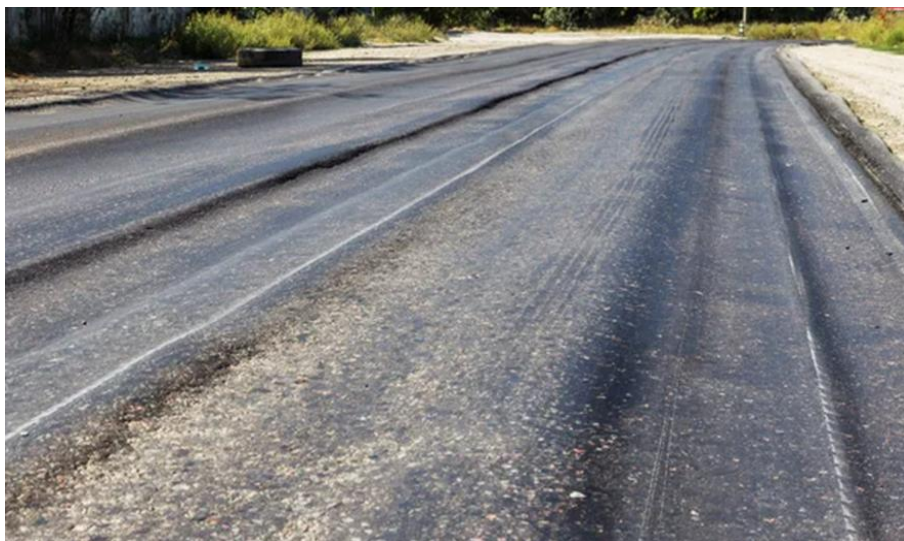
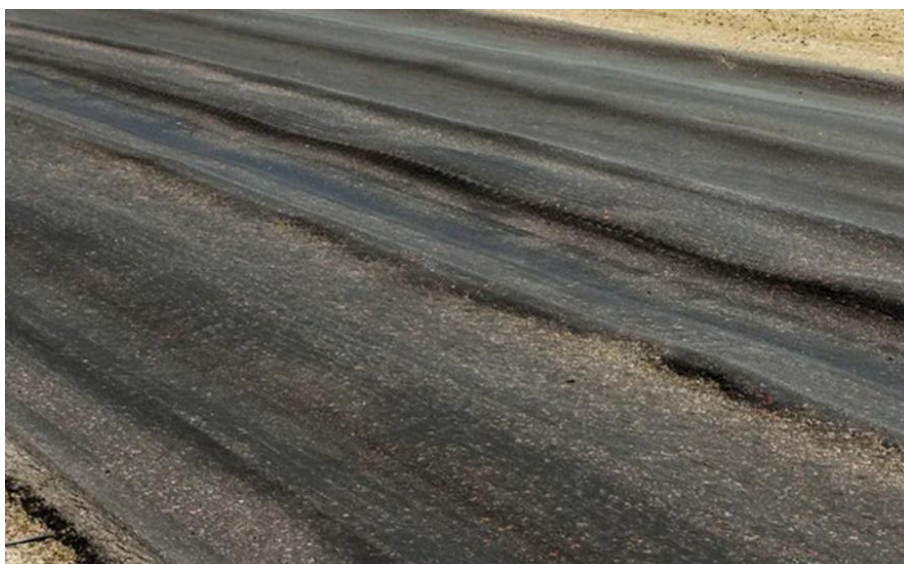
On pavements that do not have a good base or where vehicles with excess weight circulate, ripples appear, displacing the CBU asphalt to the intermediate regions where the wheels of trucks and vehicles pass.

*Figure 23 - Deformations or ripples caused by the passage of very heavy vehicles and/or poor quality of the applied base*
